# CLOVELLY WETLAND STUDIES

## ANNOTATED BIBLIOGRAPHY OF RESEARCH CONDUCTED IN / ON / INCLUDING THE CLOVELLY WETLAND AREA

August 2016

**Implications for freshwater ecosystems of the  
installation and long term impacts of a  
proposed underground electrical cable, in  
Clovelly, City of Cape Town**

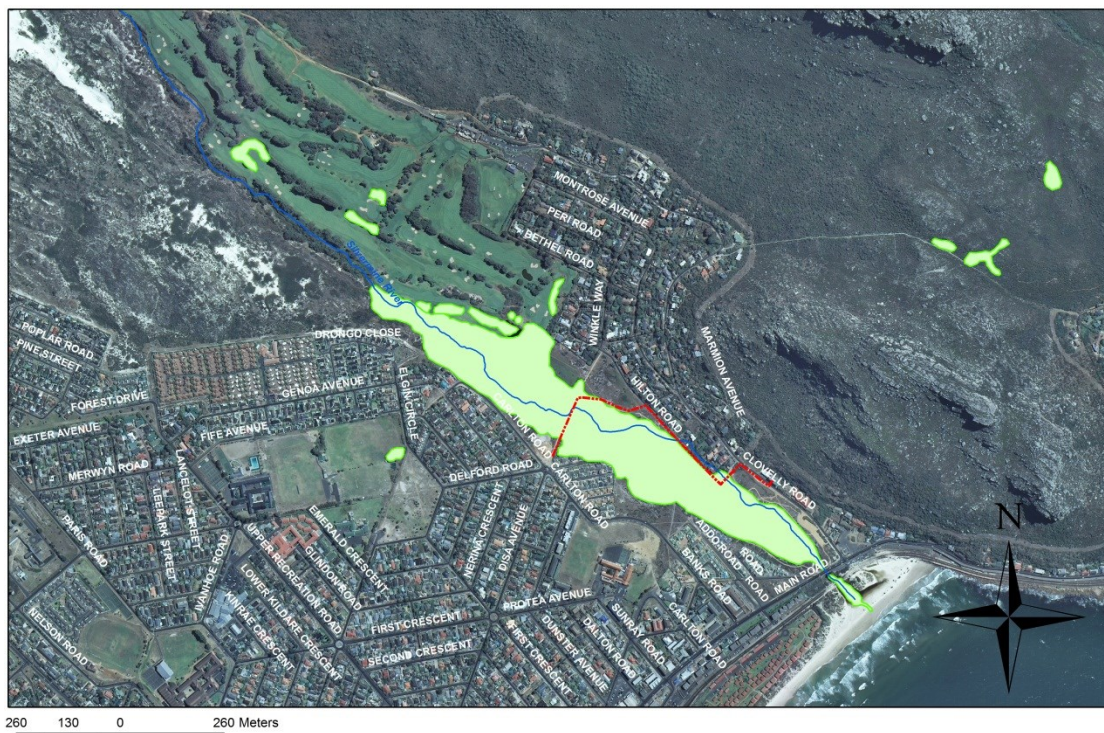
**Figure 2** 2010 aerial photograph showing the proposed alignment of the electrical cable, in its extent through the Silvermine River and its associated wetlands only. Wetland extent shown as green polygons, as mapped by the City of Cape Town' (2009) GIS layer. Low flow channel of the Silvermine River shown as blue line.

In the vicinity of the northern river crossing, abutting Clovelly Road, it is envisaged that trenchless technology would be used to cross the river, with the cable being passed beneath the river within a “sleeve”, cored beneath the river bed. The sleeve would be installed by means of a rig, which would be positioned outside of the river / wetland edge.

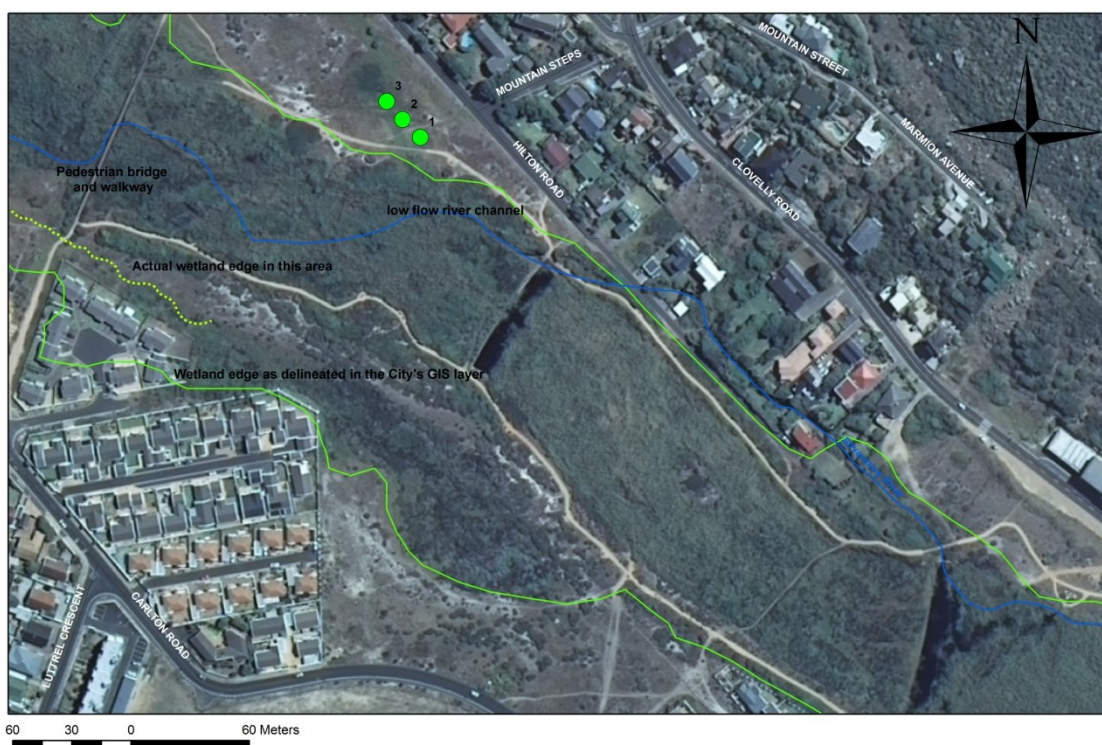
**Figure 3** 2010 aerial photograph (as in Figure 2) showing wetland extent as per the City's (2009) GIS layer) (unfilled green polygon); river channel (blue line), spot locations (numbered green circles) showing positions of the depressional wetlands (referred to as hillslope seeps in Emms and McDonald (2012) and with dotted green line in the vicinity of the pedestrian bridge showing the revised wetland edge in this area, based on Day (2009)'s delineation in this area and ground-truthing in 2012.

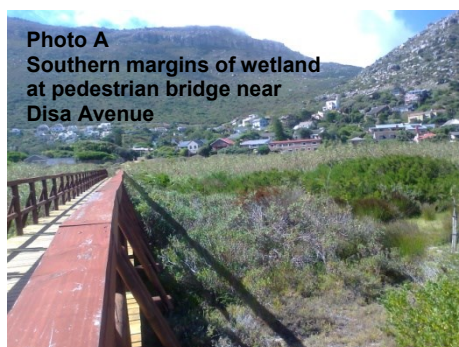
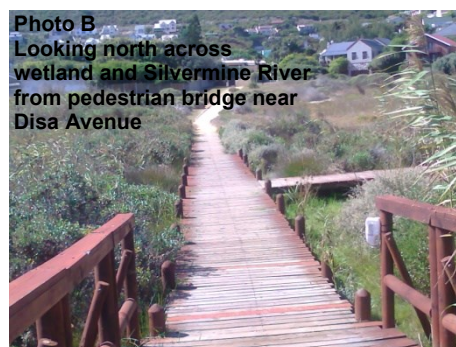
- The permanently inundated to saturated portion of the Silvermine River itself, where it passes beneath the wooden pedestrian bridge linked to Disa Avenue, including its seasonally moist to permanently saturated wetland margins on either side of the permanent wetland (Photos A and B, below, and waypoints 14 to 15 in Emms and McDonald 2012): Day (2009) delineated these wetland margins, describing them as a clearly defined band of permanently saturated, seasonally shallowly-inundated wetland, dominated by (dwarf) *Elegia tectorum*, *Ficinia nodosa* (on

slightly elevated margins and nodes) and, in places, *Carex* spp. In places, *Phragmites australis* also occupied this zone, forming dense but relatively discrete stands along the permanent wetland edge. On the left hand (northern) side of the permanent wetland, dense stands of *Cyperus textilis* and *Senecio halimifolius* occur within a mosaic of *Stenotaphrum secundatum* (Buffalo Grass) / *Ficinia nodosa* clumps.

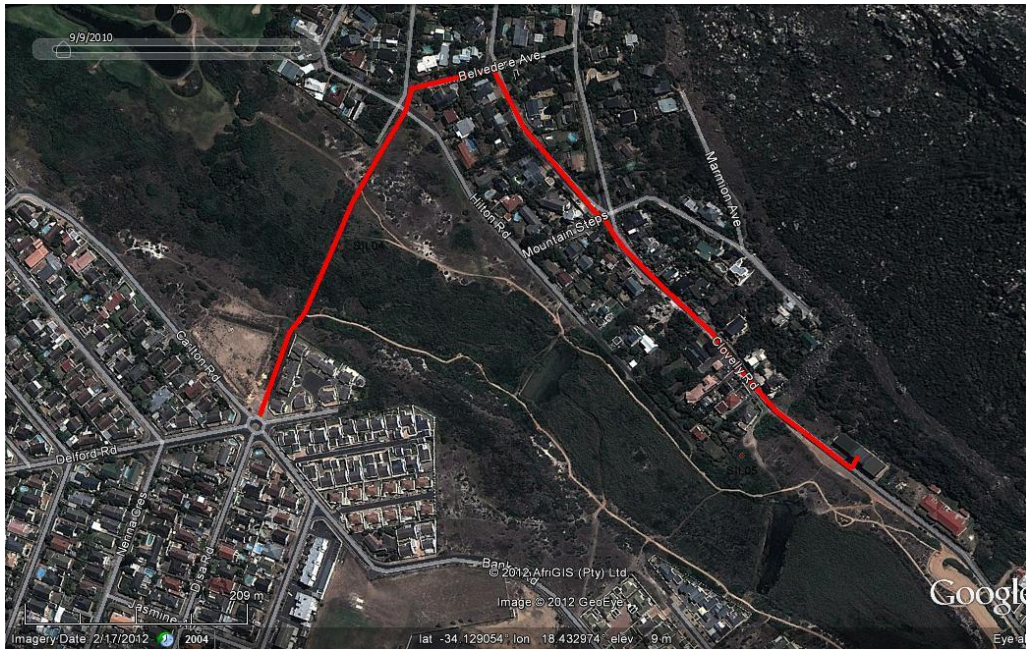
Figure 1 Revised alignment of proposed cable line

Minor re-alignment is recommended, in the vicinity of the northern crossing of the low flow channel, to avoid an existing stormwater outlet into the system. For the rest, mitigation measures centre on minimising the extent of disturbance through strict controls during construction and rehabilitation of disturbed areas after construction. The timing of construction is considered an important aspect of disturbance mitigation, and it is important that project planning take cognisance of the need for construction to take place outside of the wet season.
